# **FOLLOWING IS A SAMPLE OF A RESIDENTIAL INSPECTION REPORT COPYRIGHTED BY FORESIGHT ENGINEERING & INSPECTIONS, LLC.**

REPORT # SMC 10A-XXXX

A SINGLE FAMILY RESIDENCE AT  
**XXXXXXXX, HOUSTON, TX 77077**

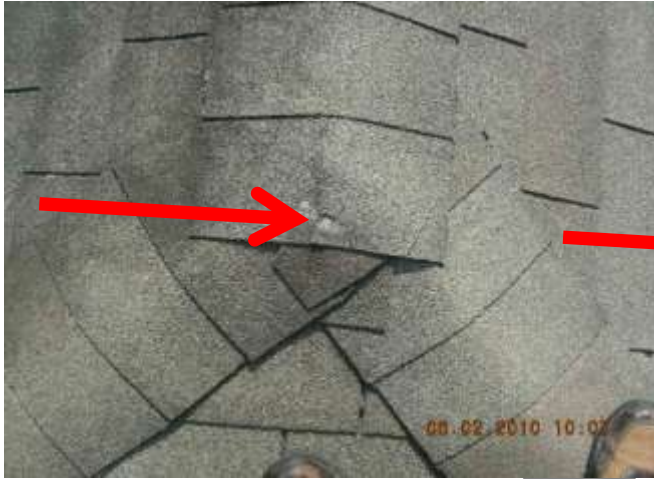
3. Nail heads were exposed on the roof & flashing. They should be sealed to reduce risk of water leaks in to the interior. (See photo top left)
4. Leaf pile up &/or debris is very detrimental to the life of the roof as the shingles get water soaked and deteriorated from the moisture of leaf pile up &/or debris. Roof should be cleaned. (See photo top right)

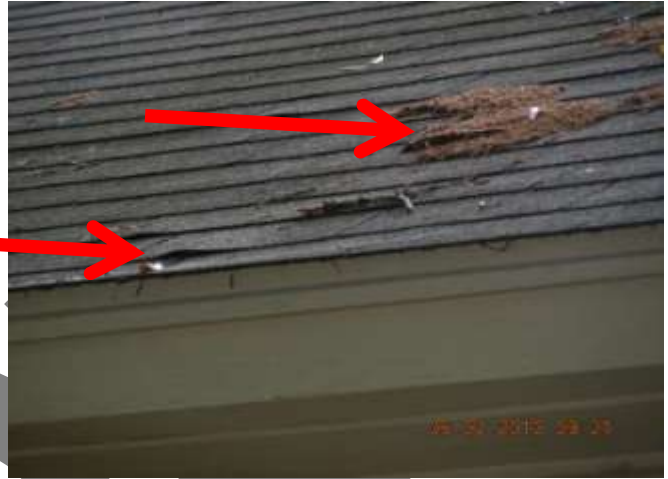
7. Shingles were lifting/fishmouthing. This should be repaired promptly to minimize shingles blown off the roof and water intrusion into the interior. (See photo top right)

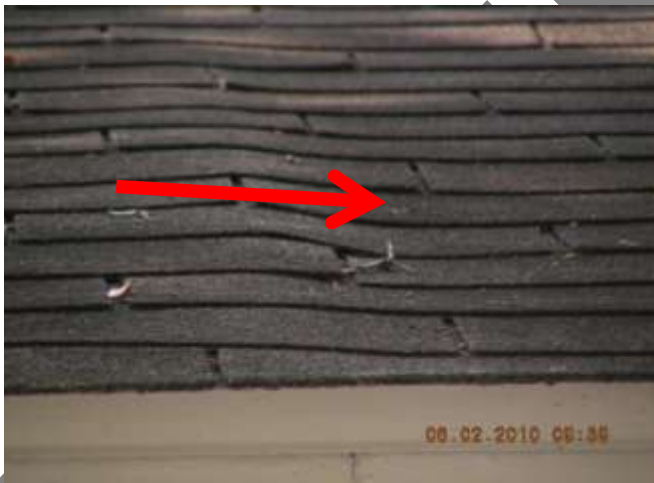
5. Dips in the roof were observed. (See photo middle left)
6. The loose flashing should be re-secured to minimize water intrusion into the interior. (See photo middle right)

8. The loose flashing at the roof penetration and fireplace chimney should be re-secured to minimize water intrusion into the interior. (See photos middle left and bottom left)

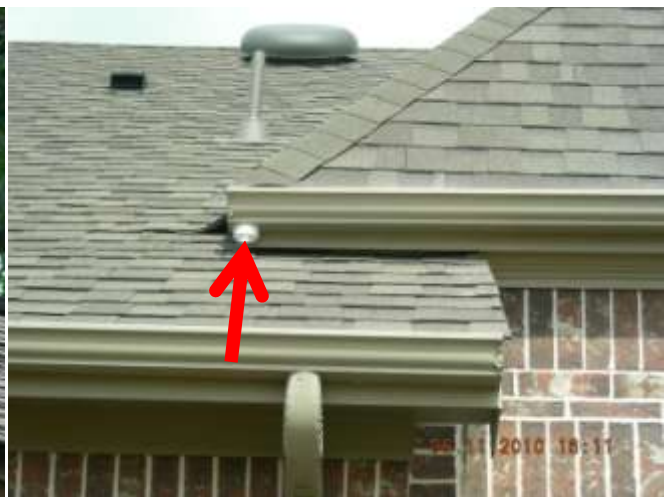
9. Downspouts &/or gutter drops that were discharging onto the roof should be extended to discharge directly into the gutters below. This condition, if left unattended, can result in premature deterioration &/or failure of the roofing, as the rain water washes the protective grit of the shingles which protects the roof from weather and ultra violet rays of the sun, downstream side of the

**downspouts &/or gutter drops. This was observed on right and left sides of the house. (See photo bottom right)**

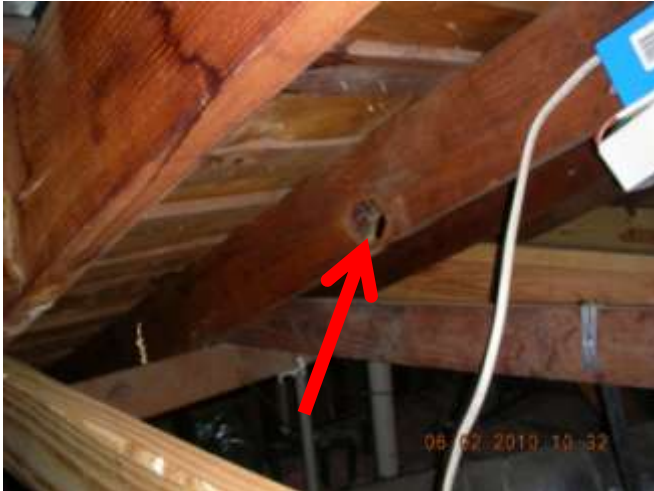
- 3. Damaged/cracked/ split rafter(s) which makes them weaker. Replace or provide additional supports. (See photo top left)**
- 4. Undersized purlins with insufficient bracing caused sag in the roof. Additional purlins of the same size as rafters with bracing at no more than 4' centers (supported on to load bearing walls) are recommended. Installation does not comply with common industry standards and should be promptly attended to. (See photo top right)**

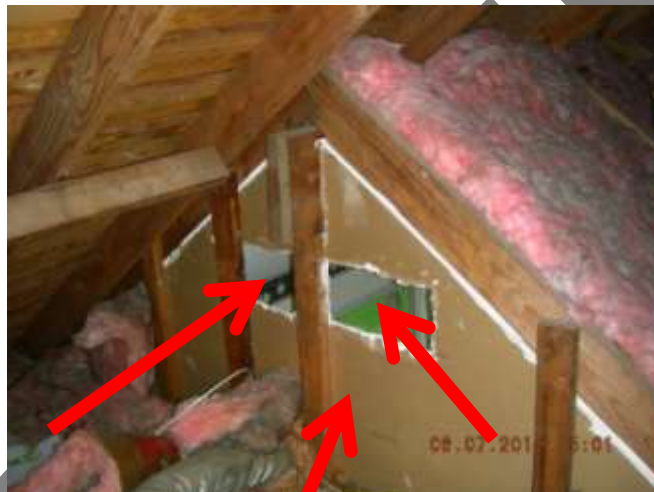
- 6. Missing wall insulation in upper and lower attics. (See photo middle left)**
- 7. Damaged sheetrock in upper attic. Attic openings should be sealed as to prevent loss of conditioned air. (See photo middle left)**

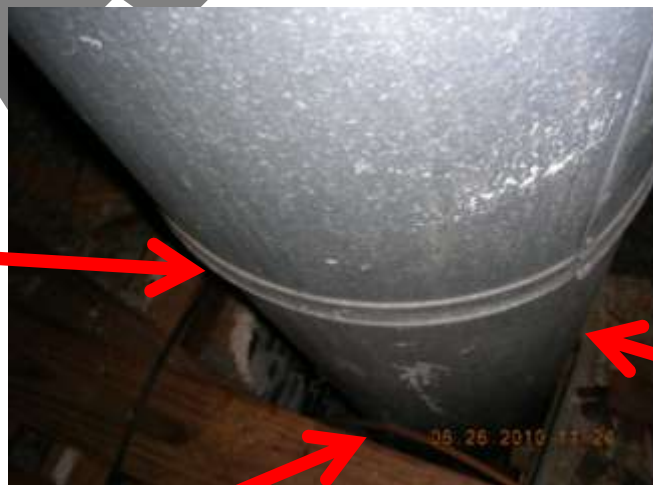
- 8. Improper bracing angle or bracing in the plane of purlin was observed behind the water heater. Angle should be between 45° and 75°. Installation does not comply with common industry standards and should be promptly attended to. (See photo middle right)
- 9. Fireplace chimney was observed to be touching roof and ceiling framing. There was no 2" clearance away from combustibles. (See photo below)

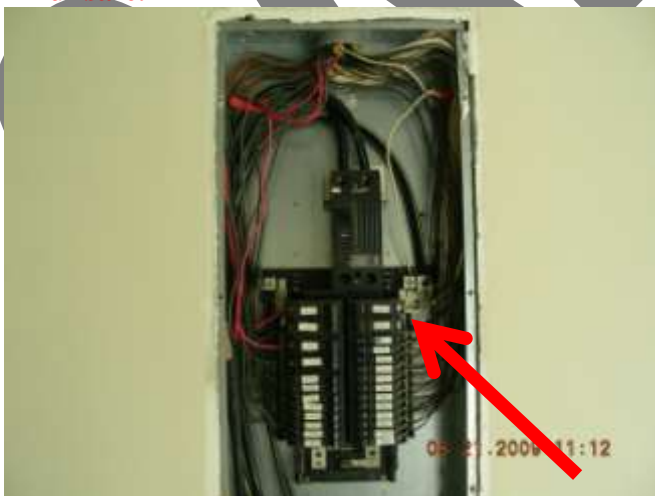
3. There was no anti-oxidant compound on the exposed feeder aluminum wiring. Use of anti-oxidant prevents arcing &/or rusting of aluminum wires. (See top left photo)

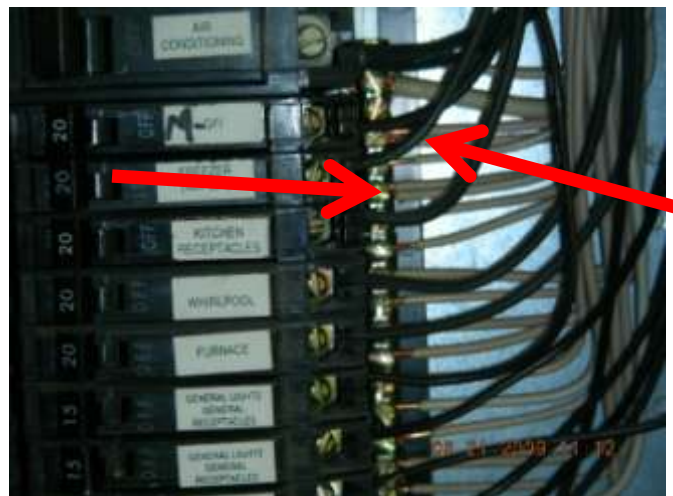
5. Neutral wires were double/triple lugged in neutral buss bar. Only one wire/screw is recommended. (See top right photo)
6. A hot wire was punctured while installing top right screw in the panel box causing shortage and fire because wire bundle was up against the panel and putting lot of pressure against the lip of the panel. This caused the puncturing and burning of the insulation. See bottom left and right photos. A cardboard was installed between wire and panel box to force the wire away from the panel lip. See bottom right photo. Top screw was not installed. This condition should be promptly corrected as it is unsafe.
