Thornton Safety and Inspection, LLC

Move-In Certified Property Inspection Report

Property address: Meridian, MS

Inspection date: 3/27/2012

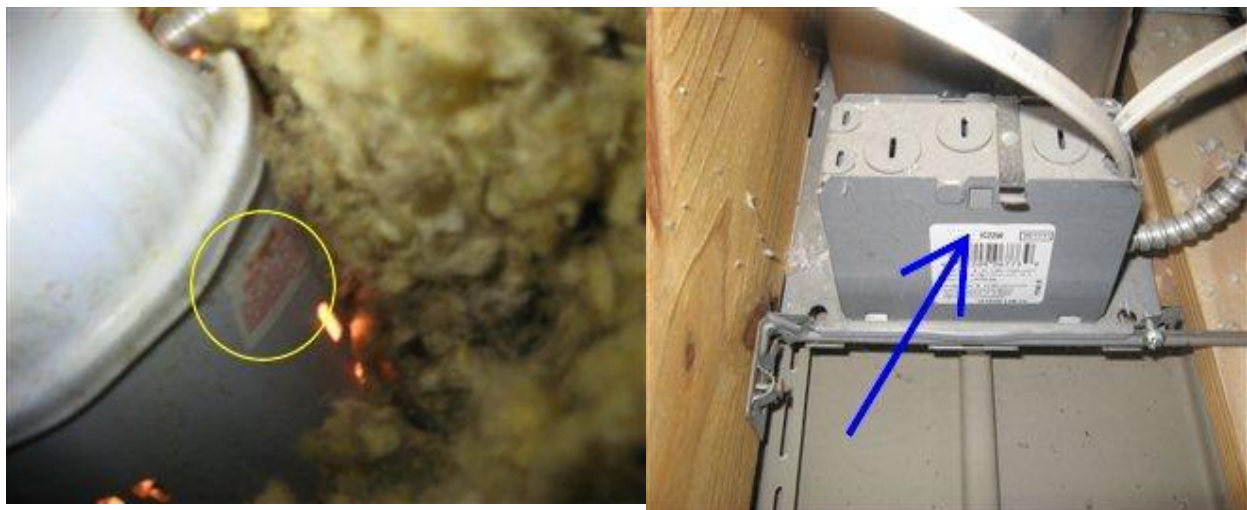
Photo 70

Recessed "can" lights that are not rated for contact with insulation are installed in the ceiling below the attic. One or more of these lights are in contact with insulation. This is a fire hazard. Insulation should be moved, and wells or barriers should be installed or repaired as necessary to keep the insulation away from these lights as per the manufacturer's installation instructions.

Warning label indicating that light is to be kept clear of insulation by 3"

CORRECTIONS VERIFIED
4/10/12

All recessed can lights were replaced with IC lights rated for contact with insulation.
Arrow indicated IC rating

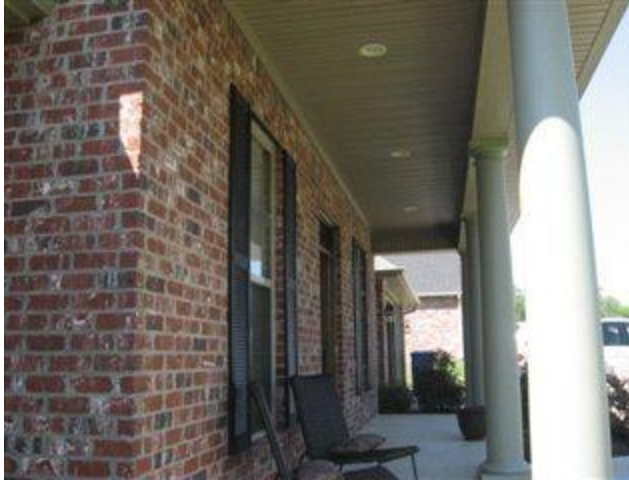
Photo 20
Recessed lights in front porch ceiling

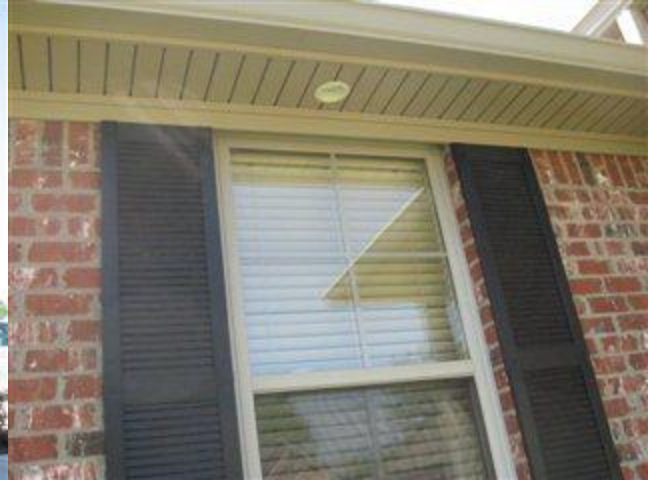
Photo 21
Recessed lights in front eave area

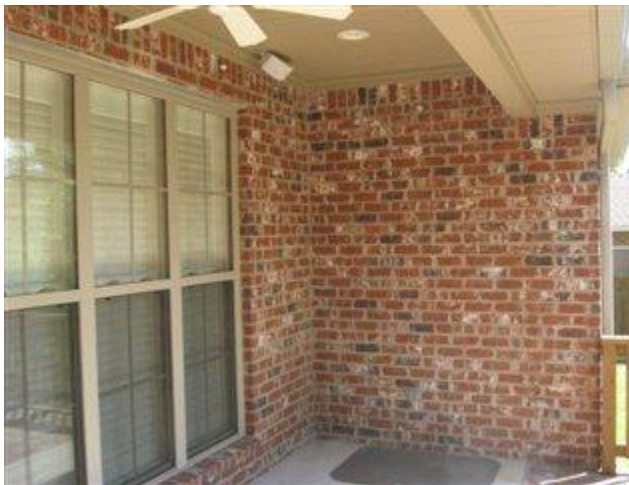
Photo 24
Recessed lights in rear porch ceiling

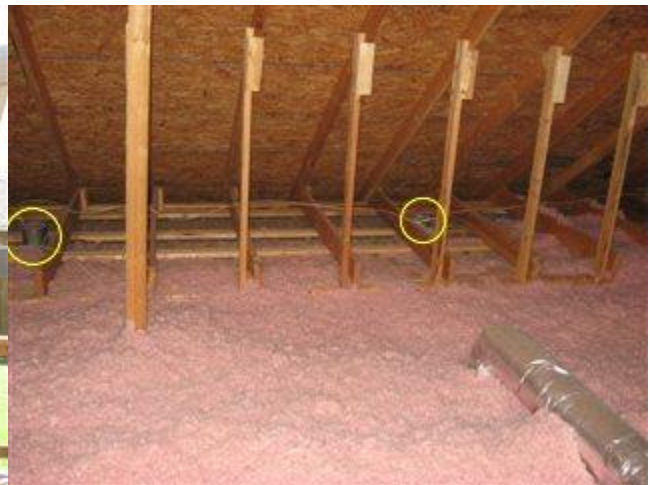
Photo 50
View from the attic of recessed can lights around the exterior

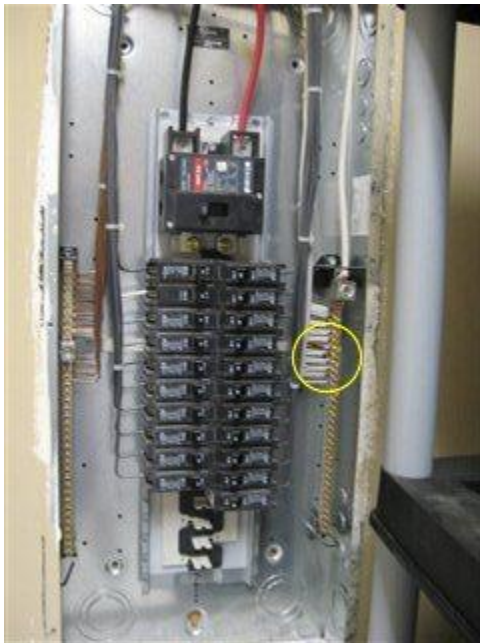
Photo 33

Neutral wires are doubled or bundled together on the neutral bus bar. This is unsafe due to the need to turn off multiple circuit breakers to work on any of the circuits using these wires. A qualified electrician should evaluate and repair as necessary.

View of sub panel with cover removed for inspection. Circle indicates area where neutral wires were doubled

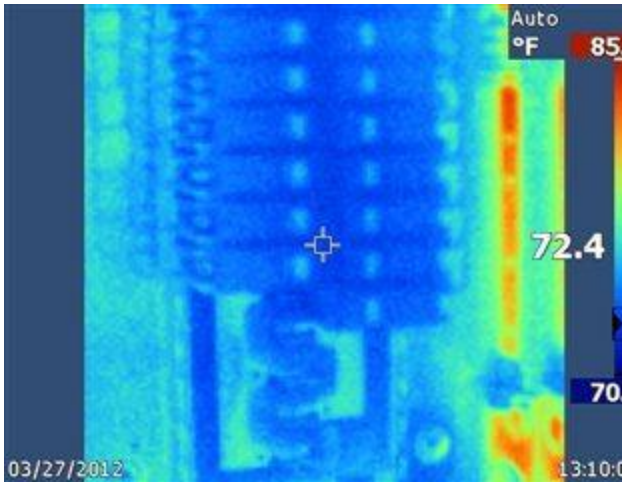
Photo 2
Infrared image of sub panel showing that breaker and conductor temperatures were normal

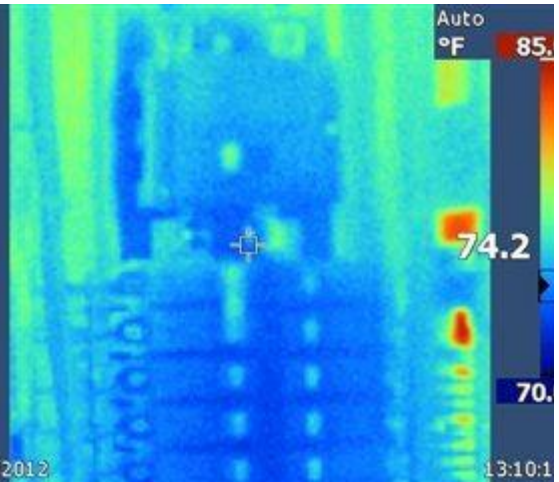
Photo 3
Infrared image of sub panel showing that breaker and conductor temperatures were normal

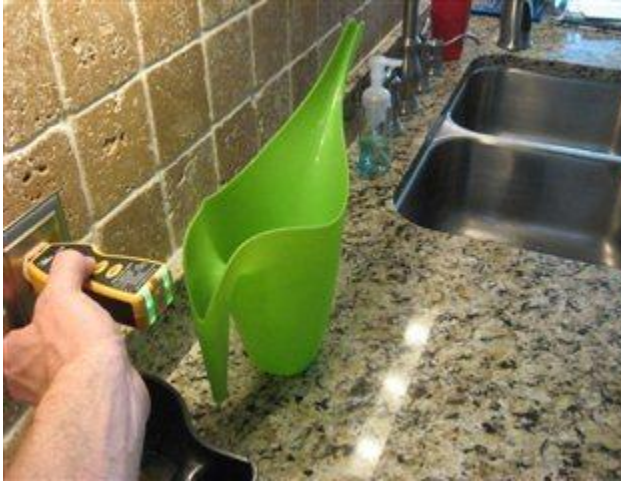
Photo 36

One electric receptacle that serves countertop surfaces within six feet of a sink appear to have no ground fault circuit interrupter (GFCI) protection. This is a safety hazard due to the risk of shock. A qualified electrician should evaluate to determine if GFCI protection exists, and if not, repairs should be made so that all receptacles that serve countertop surfaces within six feet of sinks have GFCI protection. For example, install GFCI receptacles or circuit breaker(s) as needed.

Receptacle on left side of kitchen sink did not trip during GFCI test

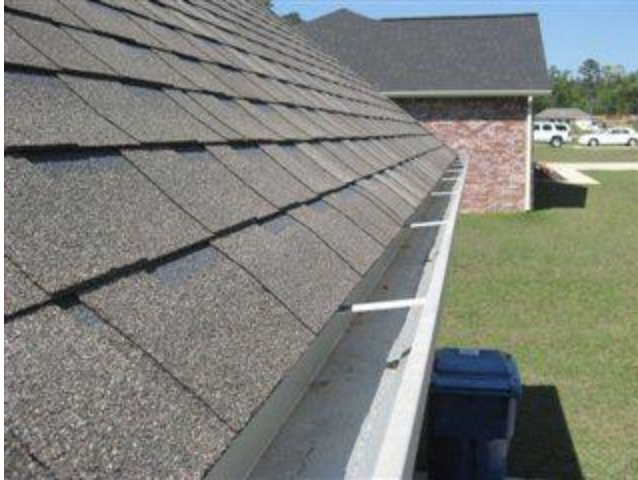
Photo 9
View of the east side showing architectural shingles with no defects noted and gutters that were clear with no debris or standing water

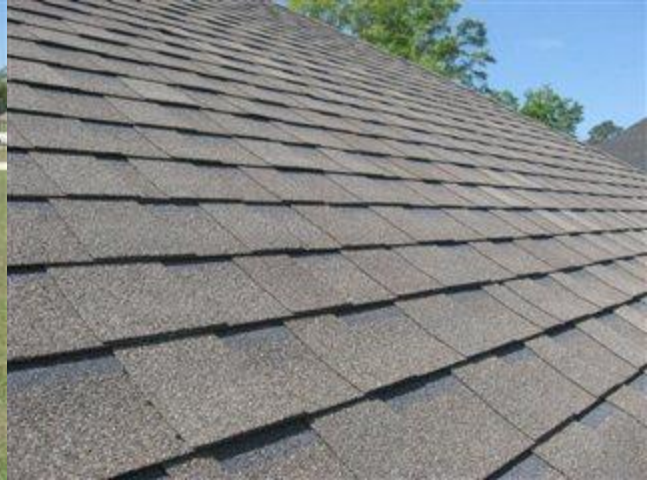
Photo 10
Architectural shingles on the east side with no defects noted

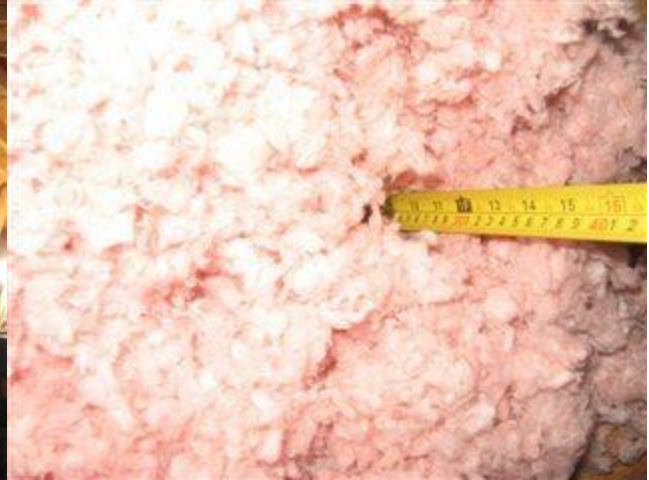
Photo 48
Showing depth of insulation measured at around 10" in accessible areas

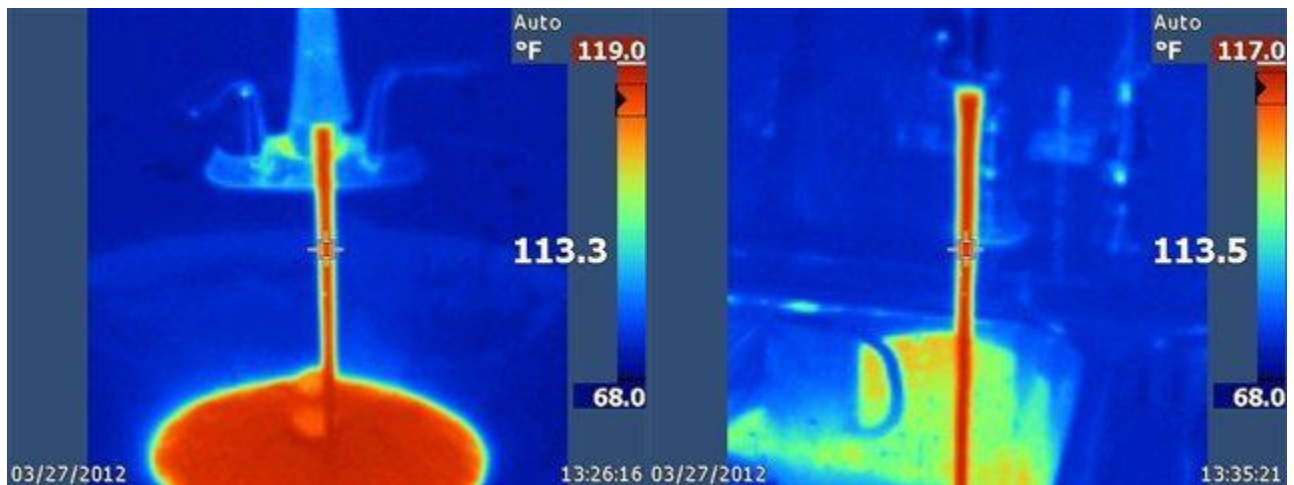
Photo 5

Hot water temperature in bathrooms was around 113 degrees F.

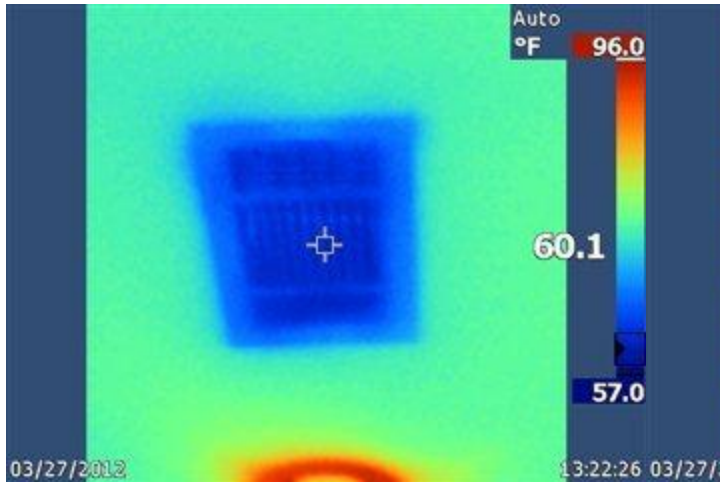
Photo 4
The cooling system supplied a consistent 59 to 60 degrees F.

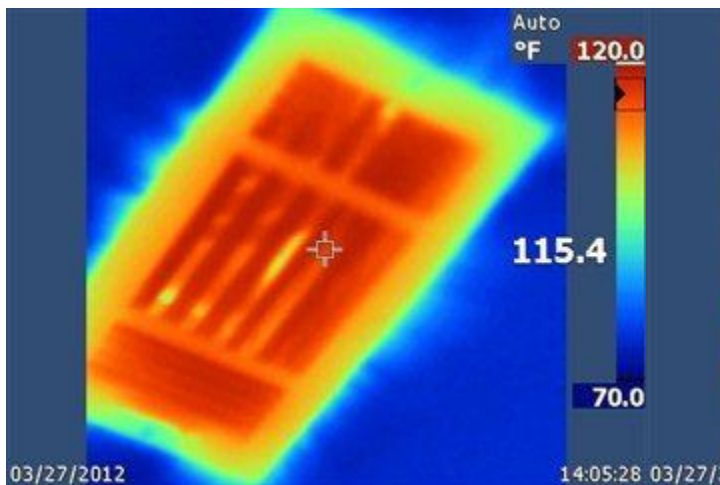
Photo 51
The heating system supplied a temperature at the supply register around 115 degrees F.

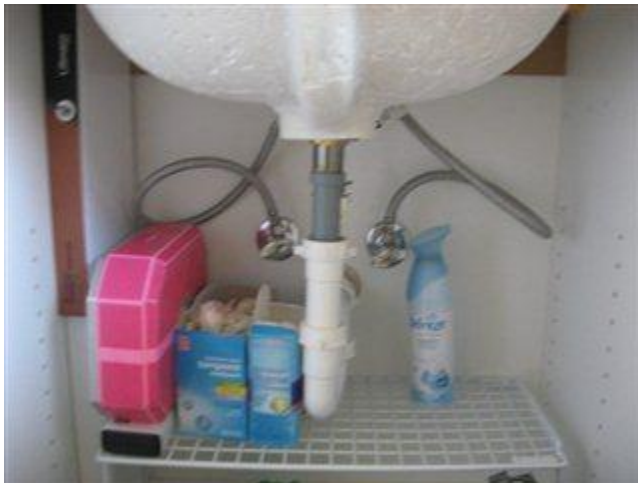
Photo 35
View of under sink areas in bathrooms with no sign of water leakage

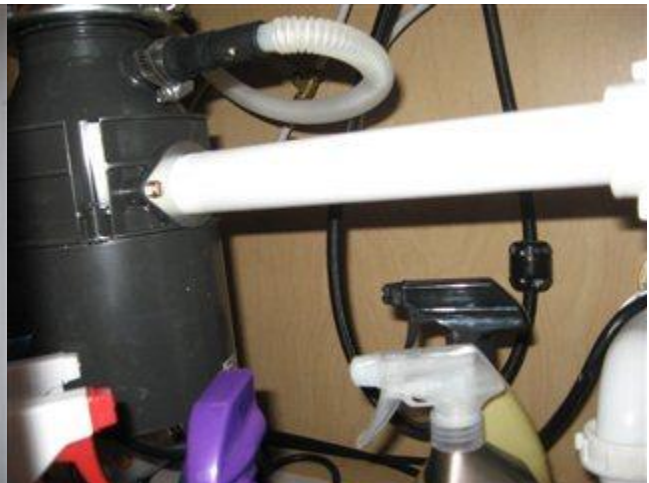
Photo 38
View of under sink area in kitchen with no sign of water leakage

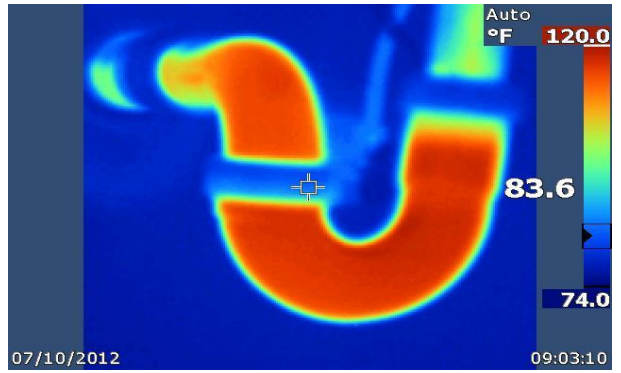
Infrared showing no blockages during hot water drainage in pipes under sinks
