SPS Home Inspections, LLC

Property Inspection Report

1111 Any Street Ln, Any Town , FL 00000
Inspection prepared for: Mr. & Mrs. Homeowner
Real Estate Agent: -

Date of Inspection: 5/1/2012 Time: 11:00 am
Age of Home: 39 Size: 3526 Heated Sq Ft
Weather: Sunny - 81 degrees

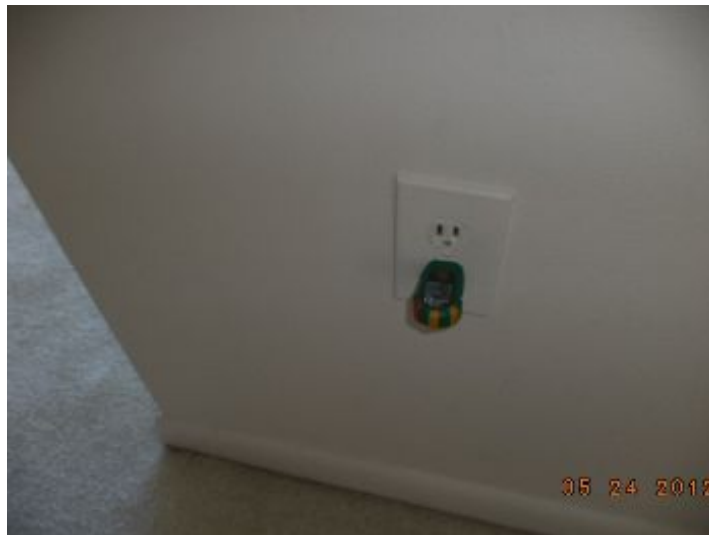
The outlet at the middle living area at the right side of the back addition opening is not functional. It is recommended that a qualified electrician repair the outlet.

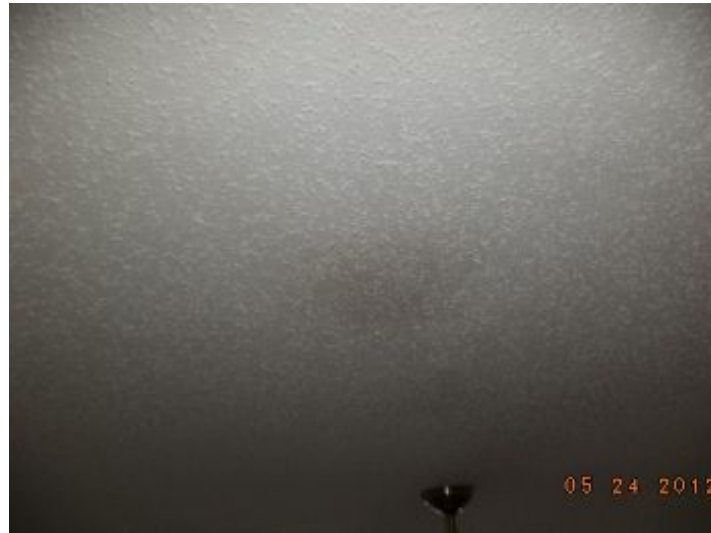
Small stains noted on the ceiling at the front living space. They tested dry at the time of the inspection.

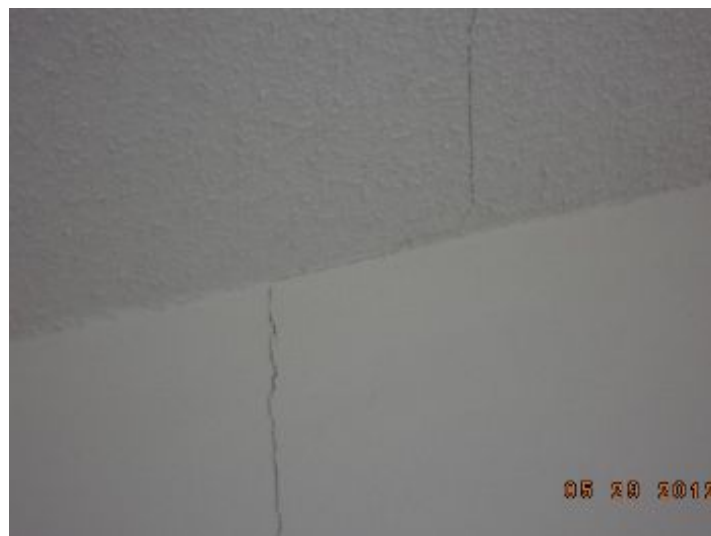
At the back addition area there are minor straight line cracks at the ceiling and wall above the opening to the room at the original exterior wall. I suggest a licensed contractor inspect for any possible repairs.

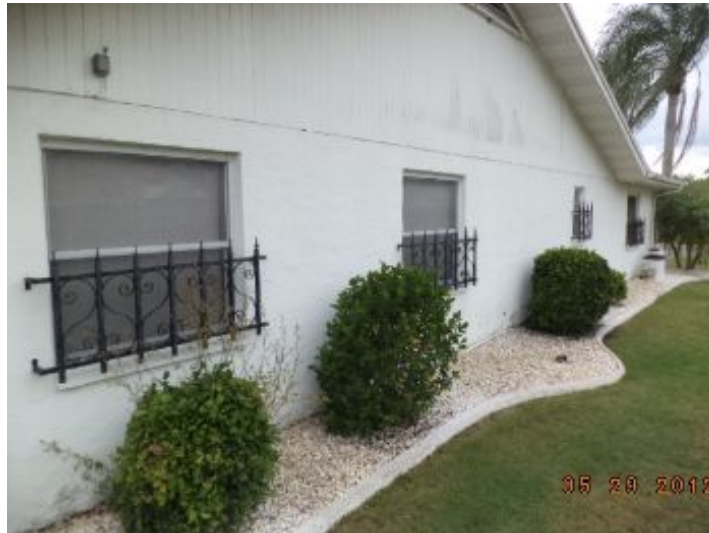
The security bars are a fixed unit and do not allow egress in case of an emergency and should be removed.

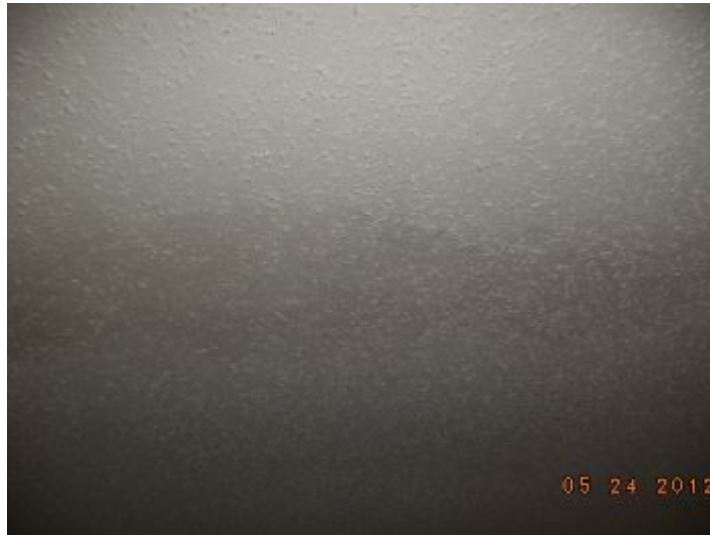
Small stains noted on the ceiling in the master bedroom. They tested dry at the time of the inspection.

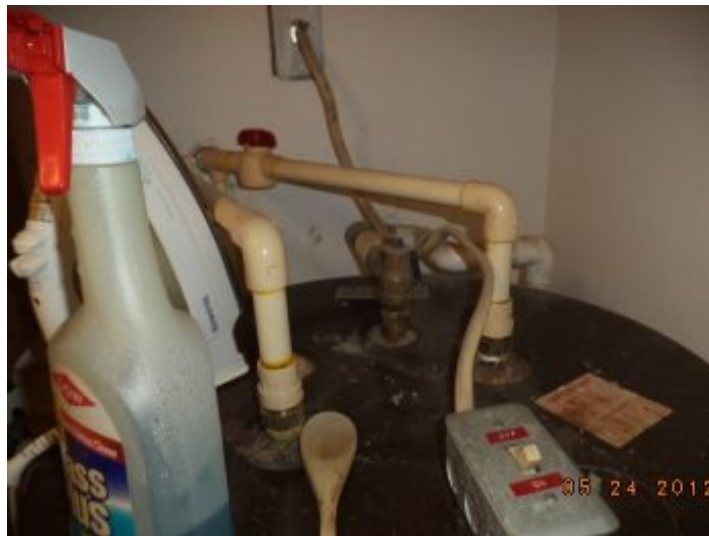
The electrical feed line is exposed. This should be in conduit. It is recommended a licensed electrician evaluate and make any necessary repairs. Safety issue.

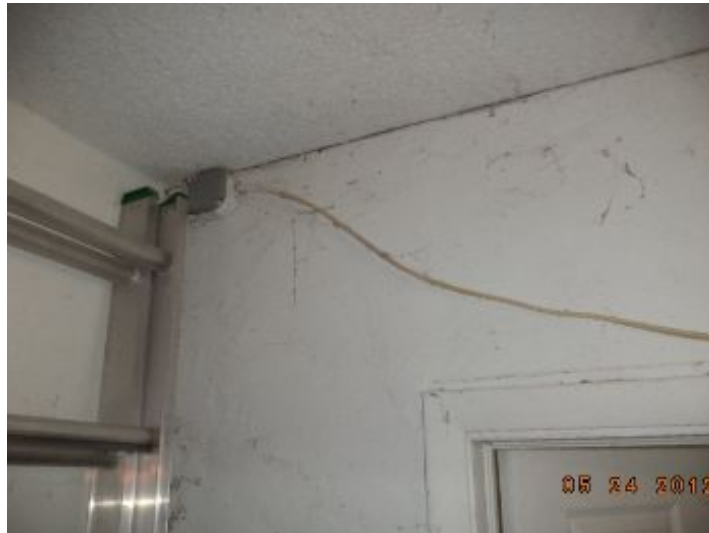
In the original 2 car garage at the back right side there are two exposed 110v wires that should be installed in conduit. It is recommended a qualified electrician inspect and make any repairs necessary. Safety Issue.

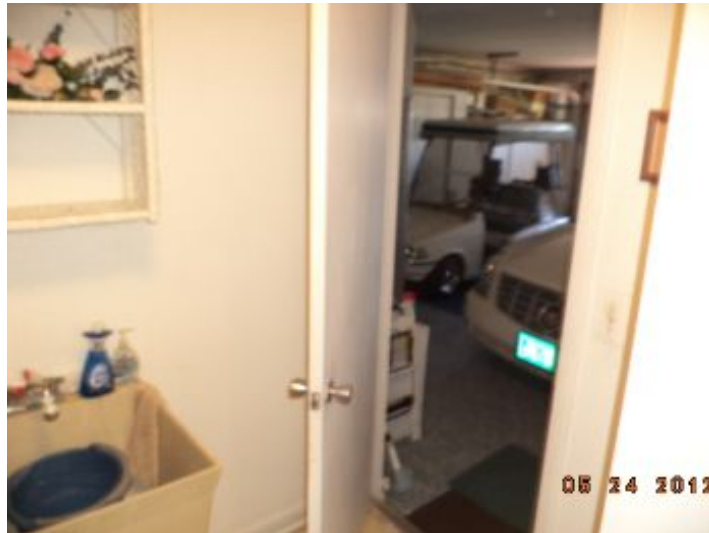
Does Not Appear to be a Rated Fire Door. It is recommended to have a licensed contractor replace the door with a fire rated door. Safety issue

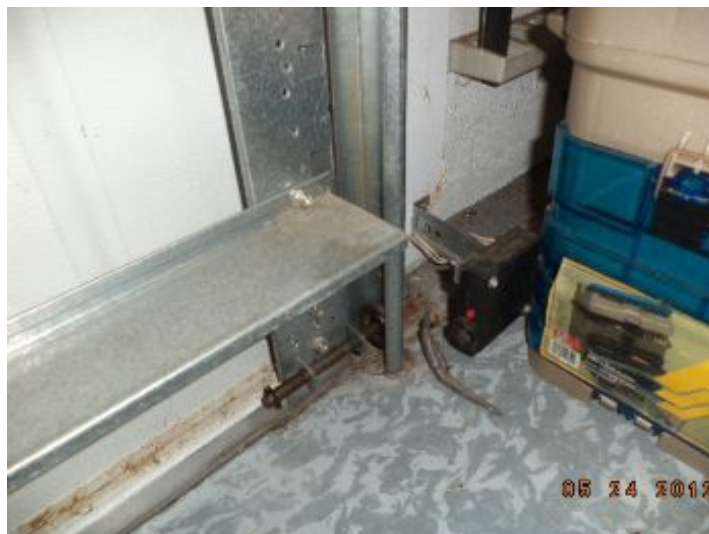
Garage vehicle door auto- reverse is inoperable on the one car garage door

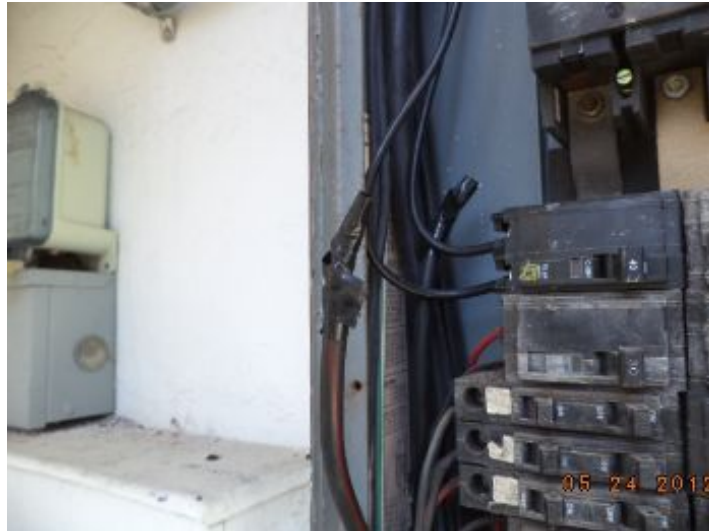
Two wires not connected to anything and have the ends taped inside the main panel. Have licensed electrician evaluate.

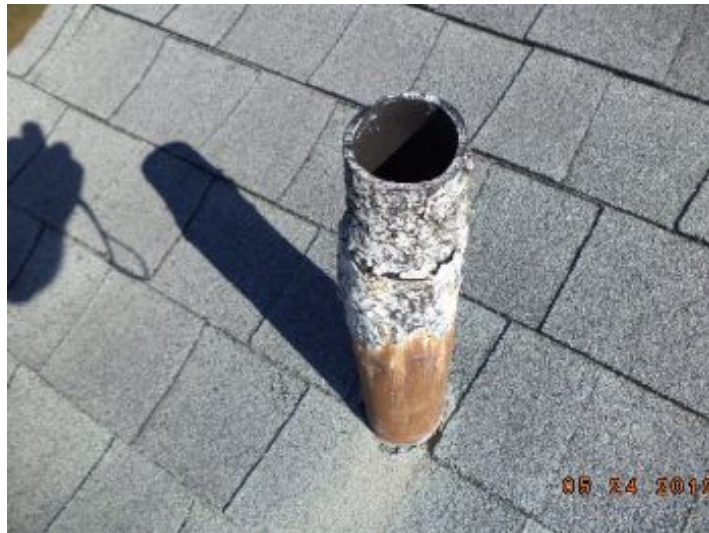
The 2" PVC vent at the left side over the master bath extends beyond the lead boot. The pipe should be cut down and a new lead boot installed to prevent any leaks. Recommend review by a licensed roofer for repair or replacement as necessary.

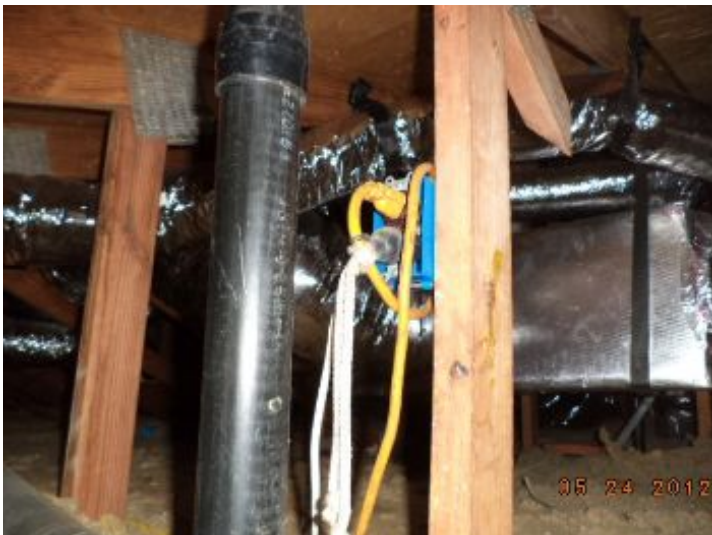
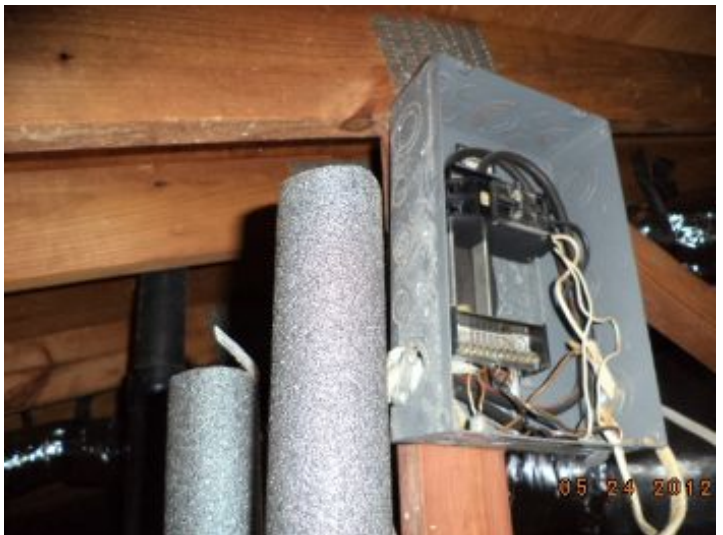
Electrical Box Covers missing or damaged, which is a potential shock or electrocution hazard. There is a junction box and outlet box visible from the laundry room scuttle hole. Both are missing the covers. It is recommended a licensed electrician replace the missing covers.

Electrical Box Covers missing or damaged, which is a potential shock or electrocution hazard. There is a junction box and outlet box visible from the laundry room scuttle hole. Both are missing the covers.

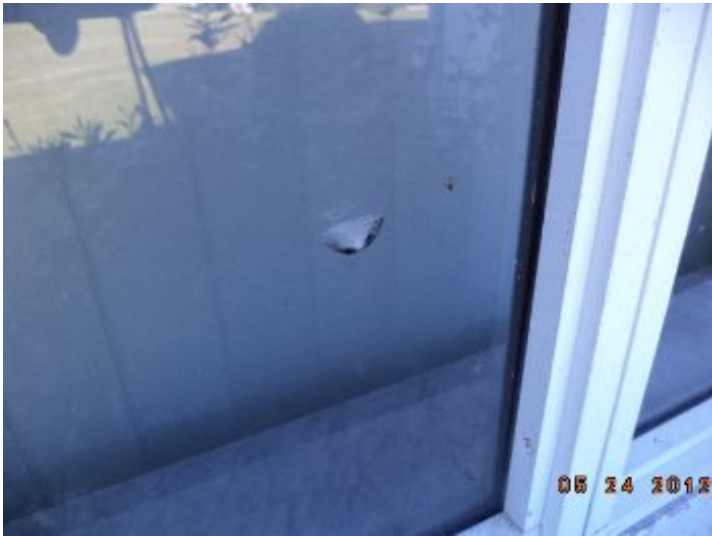
Window glass cracked. The fixed glass window at the left side toward the back of the house appears to have been hit with a small projectile and is damaged.

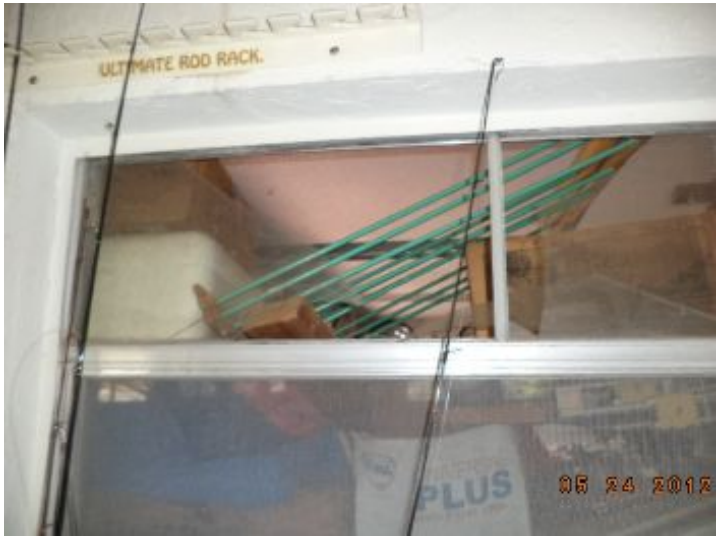
Window glass broken in between the existing garage and the garage addition on the interior. It is recommended to remove the broken glass for safety.

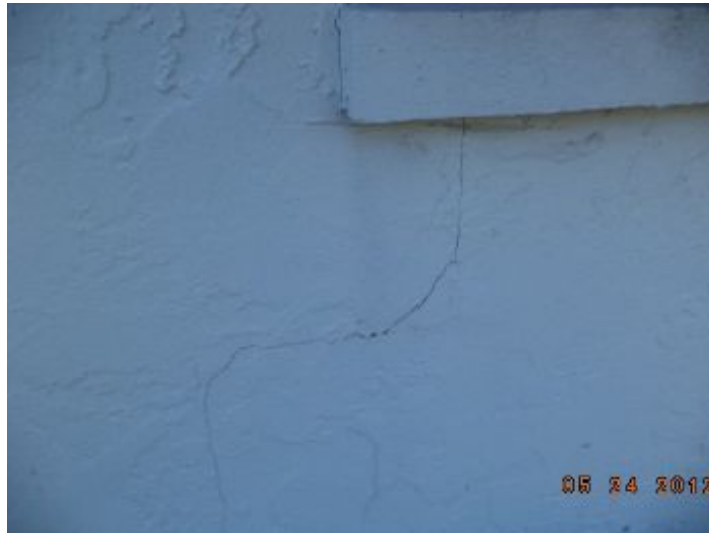
Maintenance: Caulk and seal all gaps, cracks and openings. A minor step crack at the exterior left side wall should be sealed to prevent any water intrusion. This is a typical masonry wall crack and does not appear to be an issue.

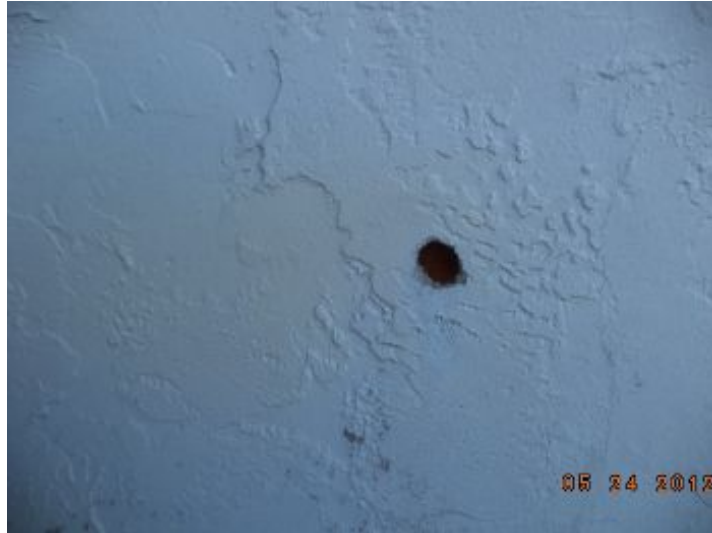
There is a small hole in the stucco at the rear elevation under the double master bedroom window. It is recommended to patch and paint the area to prevent water intrusion

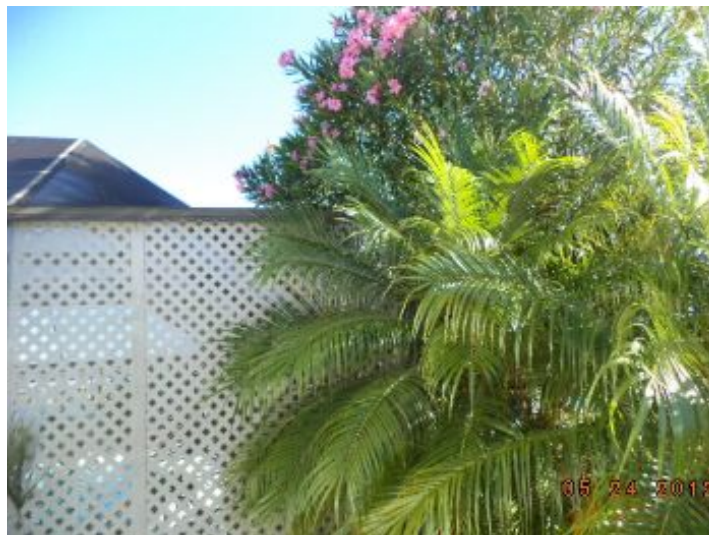
The left side of the garage had a large plant directly in contact with the building. It is recommended to trim the plant back. The palm tree at the left front side of the screen enclosure was in direct contact with the screens and may damage the screen. It is recommended to trim any vegetation as to not be in contact with the screen enclosure.

Maintenance tip : Prune or remove any plants that are in contact or proximity to home so they are at least 18 " off the exterior surface to eliminate pathways of wood destroying insects. The left side of the garage had a large plant directly in contact with the building. It is recommended to trim the plant back. The palm tree at the left front side of the screen enclosure was in direct contact with the screens and may damage the screen. It is recommended to trim any vegetation as to not be in contact with the screen enclosure.

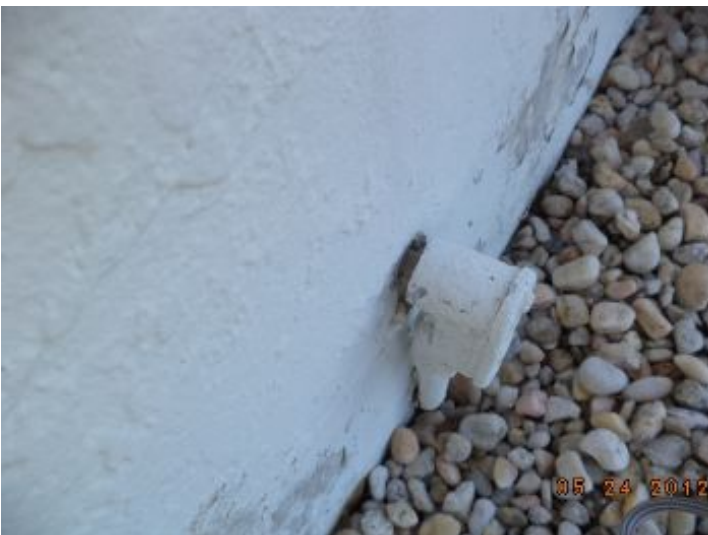
Seal around the electrical wire conduit at the front elevation, left side of the front door to prevent water penetration.

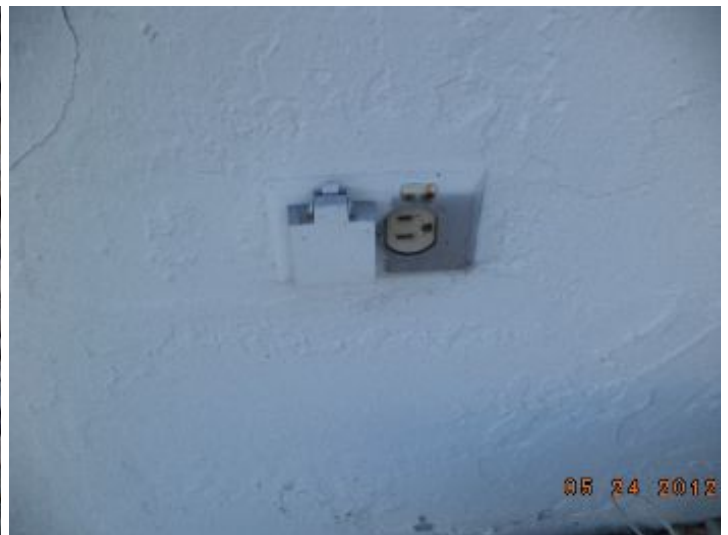
The exterior outlet cover is damaged at the left side elevation in the middle of the wall. It it recommended that it be replaced.

Replace the damaged waterproof cover on the left elevation outlet

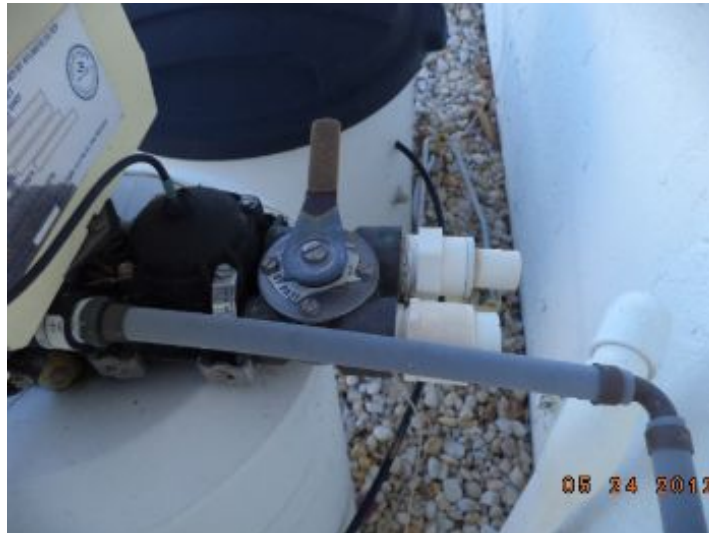
- Water softener on the left side elevation has had the supply and feed lines cut and is not in use.
- The water main shut off is located at the left side elevation in the middle of the wall.

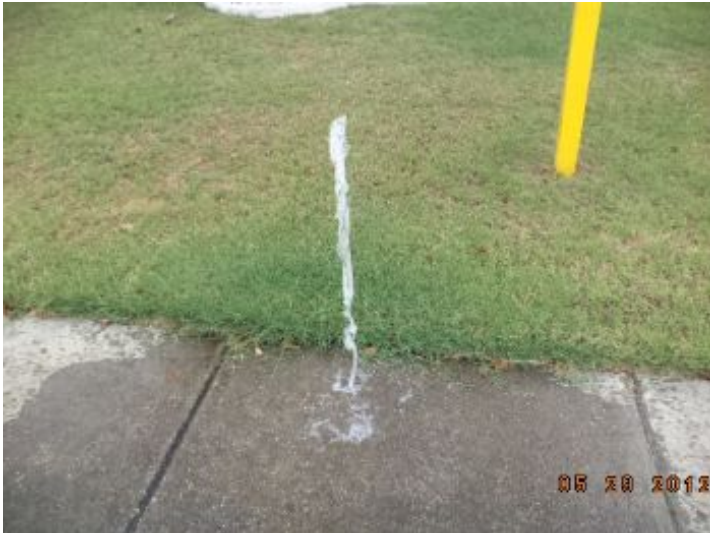
The inspector noted one broken head at the front left center. Zone 1

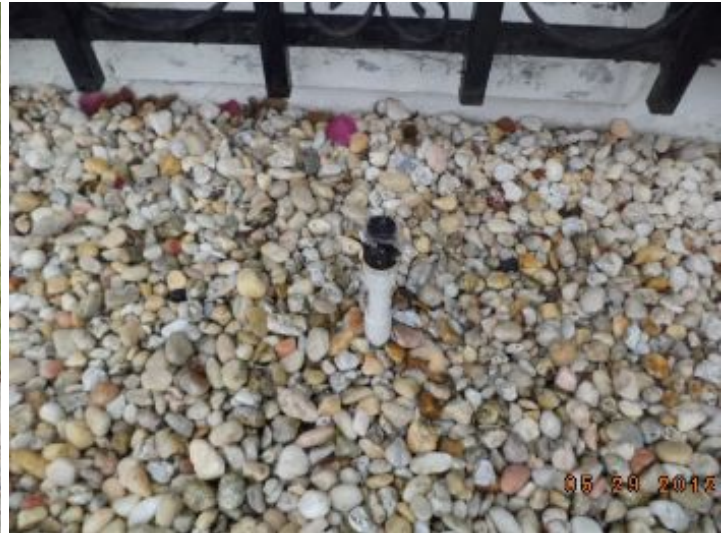
When operating zone 3, the last heads at the zone did not have enough pressure to operate properly. There were 19 heads on this zone, which is too many. I recommend a licensed landscape contractor check the system for proper water flow, sprinkler head repair and adjustment.

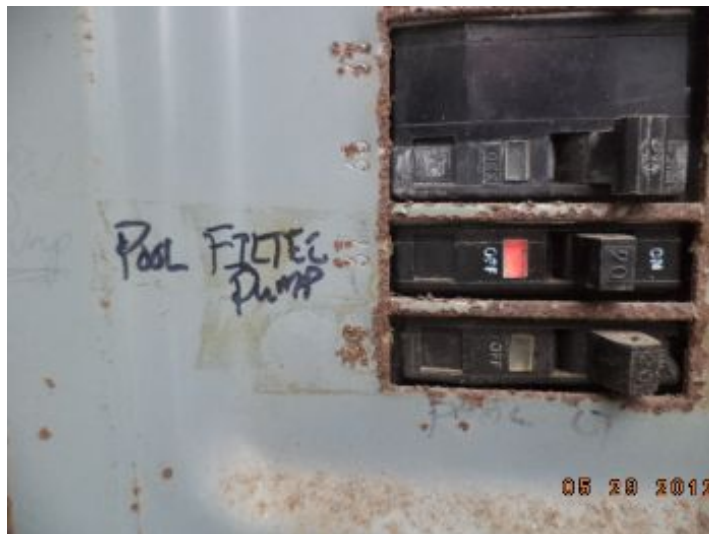
We recommend contacting a qualified pool service technician for evaluation/repair. When the breaker was turned on at the main panel box the breaker tripped right away.
