Blue Heron Home Inspections
1208 Western Pine Circle
Sarasota, FL 34240
Inspector: Joe Cockey 941-350-7415
Confidential & Prepared for client only

Home Inspection Report

305 Paradise Lane
Sarasota, FL 34234

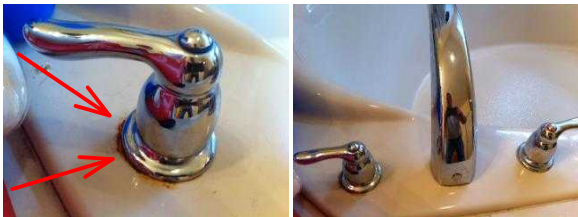
2. 2nd floor main Bathroom Tub/Surround: Fiberglass tub and ceramic tile surround **Replace caulking**
3. 1st floor Master Bathroom Faucets/Traps: Delta fixtures with a PVC trap **Rust from cold facet stem. Plumber should further evaluate.**

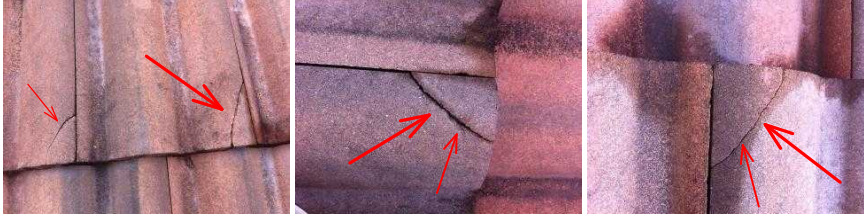
1. Method of Inspection: On roof
2. Acceptable Unable to Inspect: 75%
3. Acceptable Material: Cement tile 15-20 roof tiles like representative shown. Monitor and have roof company evaluate.

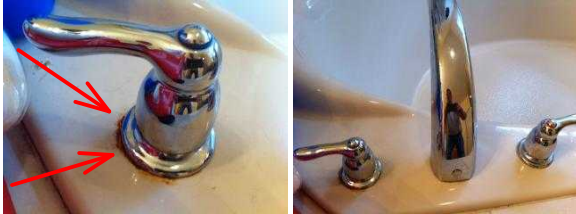
38. Marginal Faucets/Traps: Delta fixtures with a PVC trap **Rust from cold facet stem. Plumber should further evaluate.**
