Inspection Report

The \$129 Home Inspection Company

ABBREVIATED SAMPLE REPORT

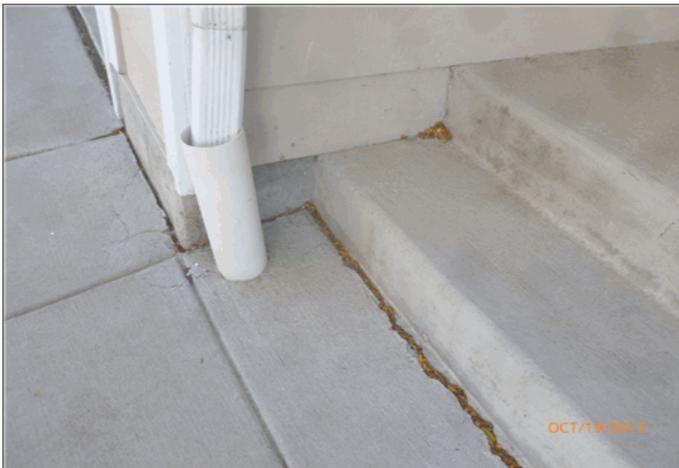
2) Sidewalks - Conditions

The concrete sidewalk and walkways were in serviceable condition at the time of the inspections **EXCEPT THAT the walk to the front porch had settled up to 2.5 inches. A TRIP HAZARD was created. SEE PHOTO. A PRIORITY REPAIR is recommended.**

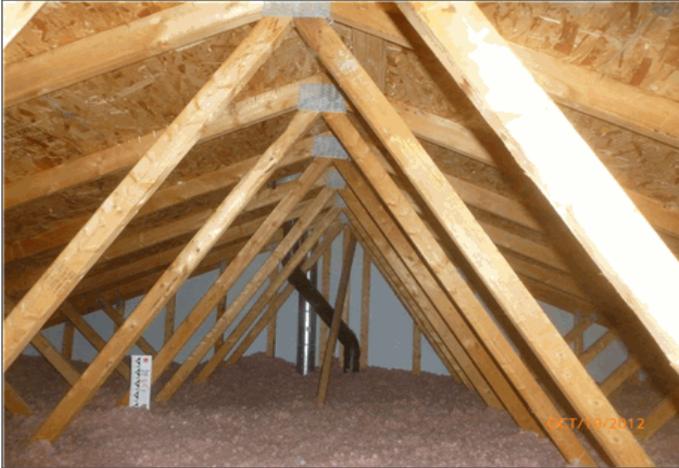
6) General Attic - Conditions

The general condition of the attic appeared serviceable. **SEE PHOTO** There was no evidence of current roof leaks, no structural members were compromised, visible wiring appeared to be typical and the plumbing and furnace vents appeared typical and serviceable.

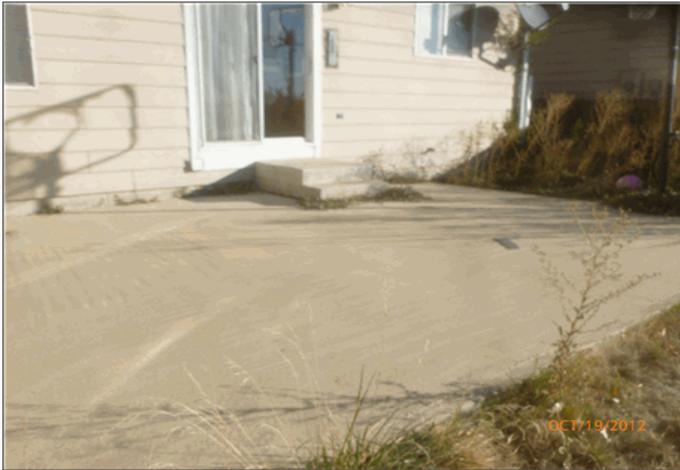
13) Patio, Deck - Conditions

The concrete patio slab had settled about 2 inches. RECOMMEND further evaluation from a concrete contractor. Mud jacking could be a cheaper solution. SEE PHOTOS.

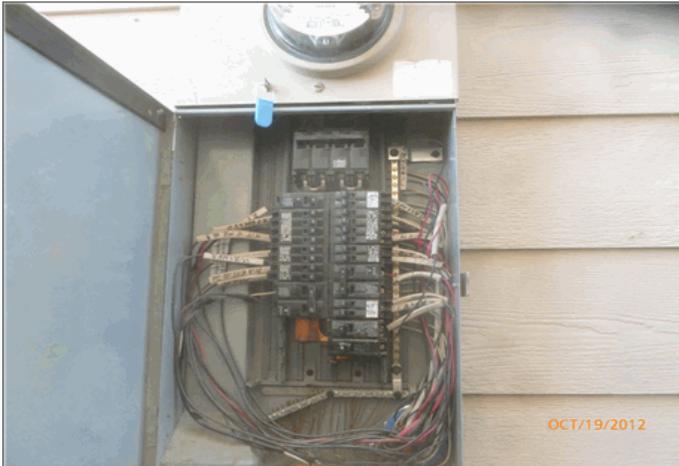
16) Electrical Panel - Conditions

The 150 amp, 24 breaker main panel appeared to be in serviceable condition at the time of the inspection. **SEE PHOTO.**

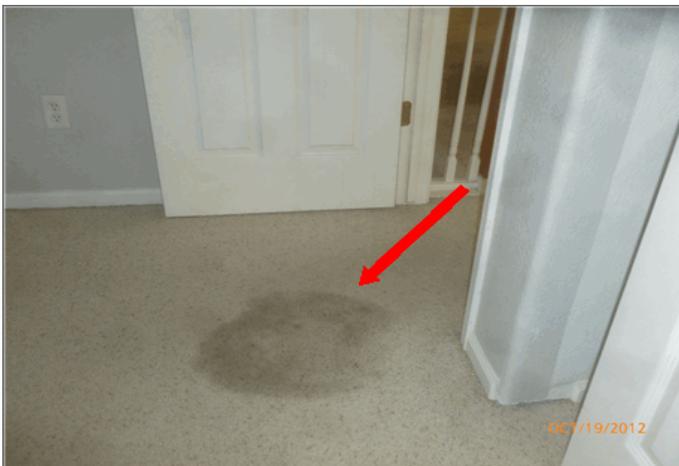
17) Floors - Materials - Conditions

The HARDWOOD MAIN FLOOR and the CARPET UPSTAIRS AND BASEMENT floor coverings were a combination of materials and appeared to be in poor condition at the time of the inspection. **Some of the carpeting had moderate to major stains. Replacement might be needed. SEE PHOTO.**

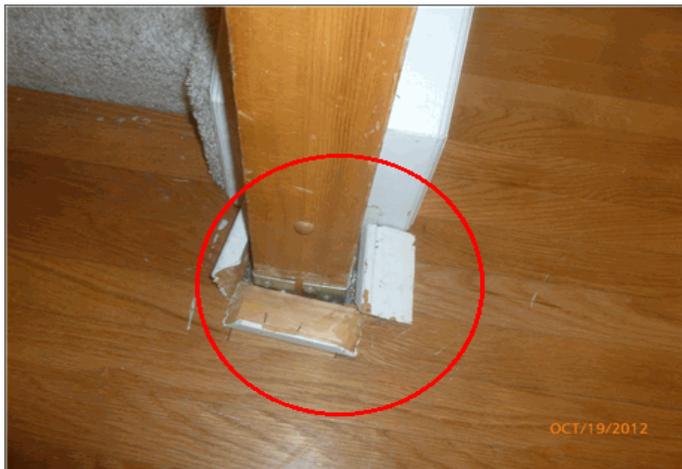
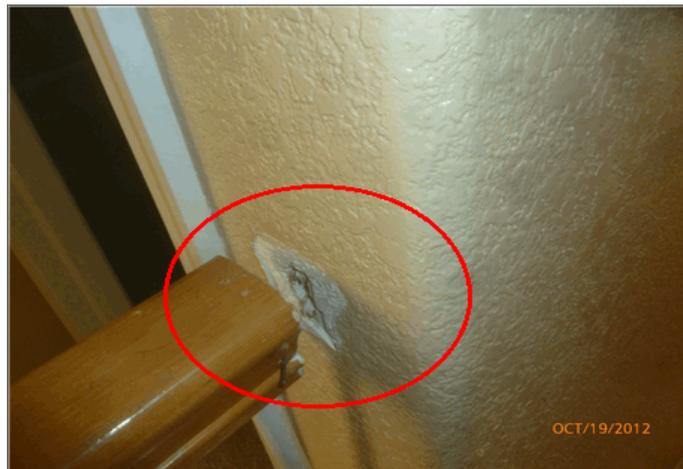
18) Upper Stairs - Conditions

The 3 upper stair posts and ballisters were loose. **A PRIORITY REPAIR is recommended. SEE PHOTOS.**

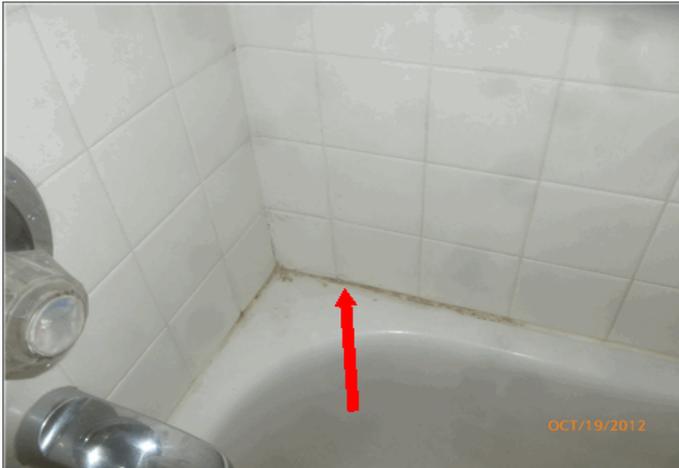
36) Tub(s) - Conditions

Tub and shower conditions were serviceable at the time of inspection. The back side of tub and shower faucets and drains, and conditions inside of walls are not visible for inspection. **HOWEVER....both perimeters needed silicon and grout touch-up. Very small penetrations were present. SEE PHOTO. A PRIORITY REPAIR is recommended.**

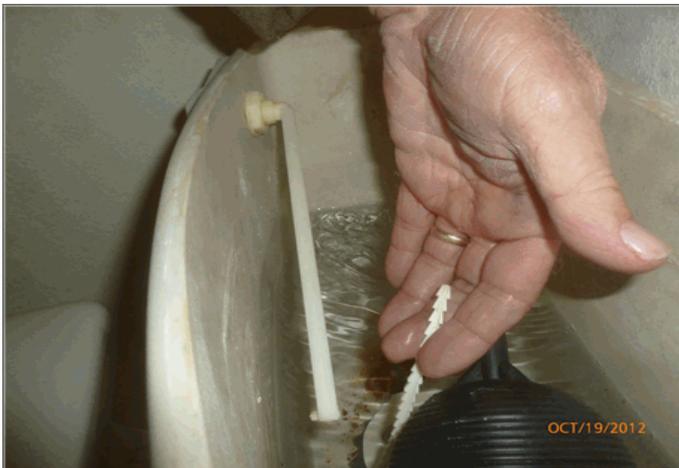
37) Toilet(s) - Conditions

Three of the 4 toilet(s) appeared to be in serviceable condition. Most mechanisms were operational; no cracks or leaks were observed; and the toilet was secure to the floor. **HOWEVER....the master bedroom bath toilet flapper valve was leaking and the basement toilet mechanism needed repair. SEE PHOTO. A PRIORITY REPAIR is recommended.**

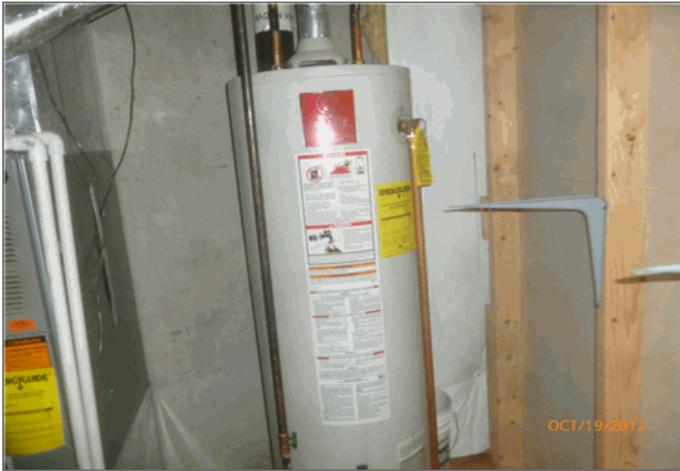
41) Water Heater - Conditions

The 40 gallon, KENMORE water heater was located in the basement and was operable at the time of inspection. The pressure relief valve and discharge pipe were in place and there was little rust. The burner appeared to be serviceable. This does not however guarantee future performance. These units can go out at any time. The service life is said to be from 10 to 15 years, but many last much longer. **SEE PHOTO.**

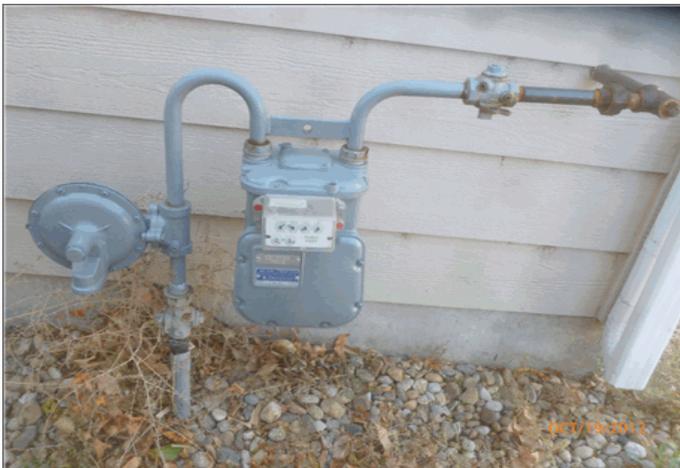
The gas shut off for the entire house was located at the meter. **SEE PHOTO.**

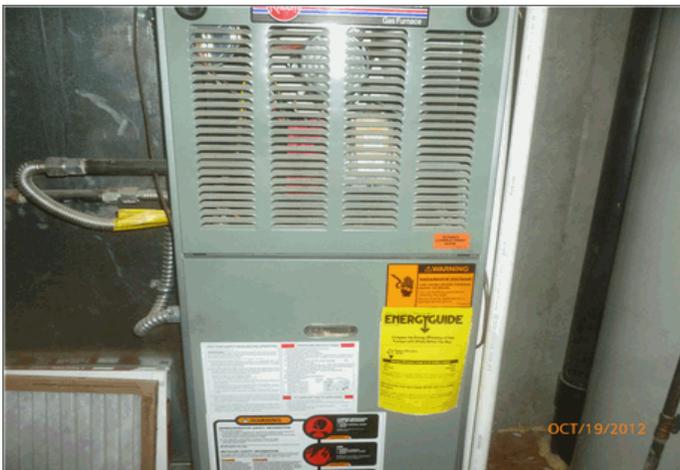
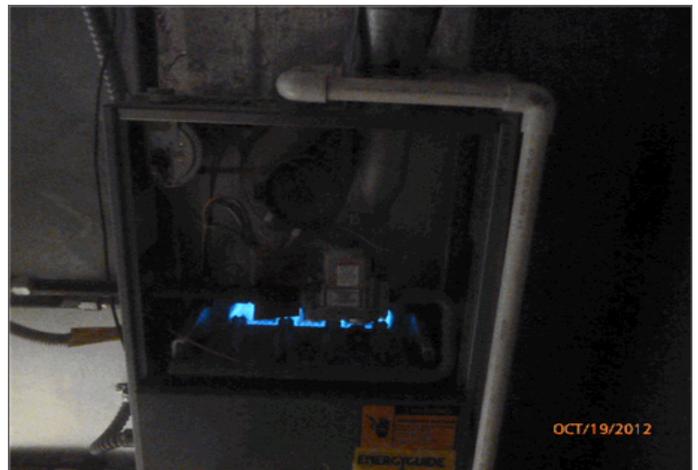
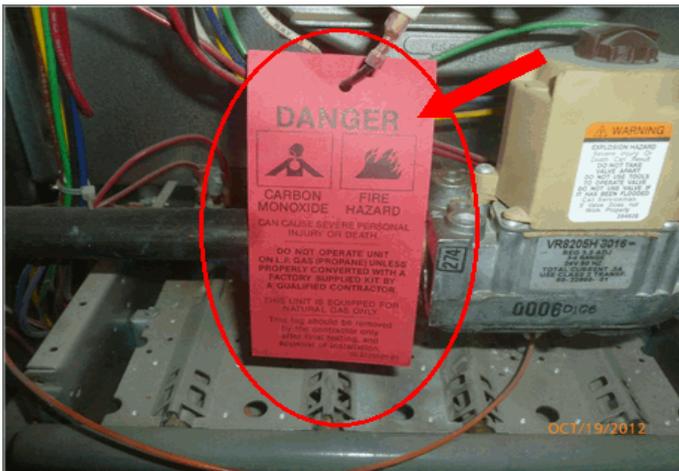
45) Heating Unit - Conditions

The gas fired furnace was turned off at the furnace switch when inspector arrived. **A red tag cautioning against carbon monoxide was present** within the unit. While it is possible that this tag was not removed at the time of installation, inspector must assume and recommend that furnace needs servicing by an HVAC company who is qualified to remove the red tag. **A PRIORITY REPAIR is recommended. SEE PHOTOS.**

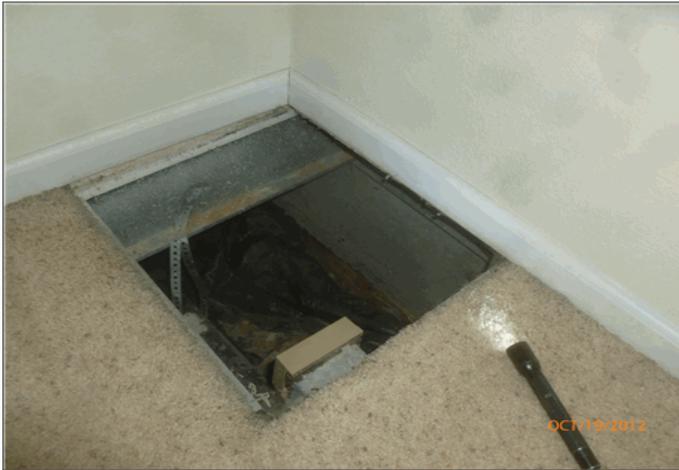
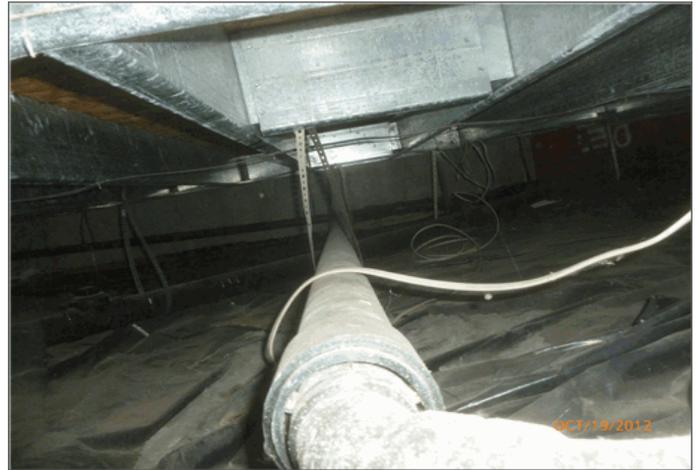
51) Wood Structural Floor - Conditions

There was a structural basement wood floor present. Inspector observed no problems with the floor.

HOWEVER...the floor was covered with carpeting and not visible. There was a crawl space beneath the floor, but there was not enough clearance for the inspector to enter the crawl space. So the crawl space was only inspected in the area near and around the small access hatch. **SEE PHOTOS.** It was observed that a proper moisture barrier was in place and that a de-humidifier system was in place and working. A passive radon reduction system was present. **For Your Information** - shallow crawl spaces under wood floors can and often do develop mold because of too much moisture. Inspector observed no mold but most of the area was not inspect-able. **Recommend monitoring this issue and, if needed, contact an appropriate contractor.**

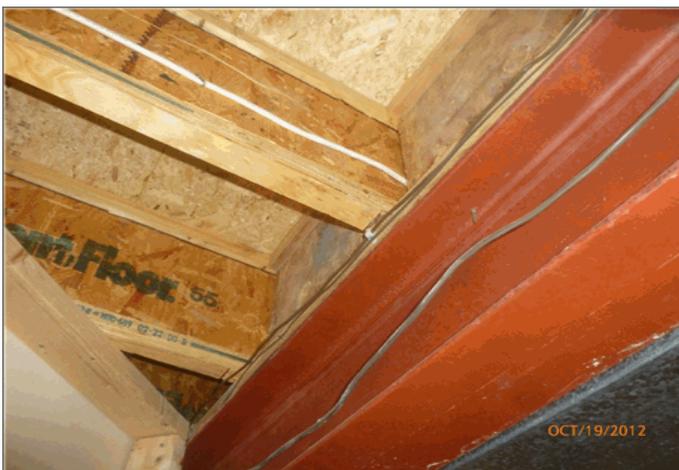
55) Description - Condition

The support for the upper floor was of I-Joists and steel I-beam. These man-made floor joists are superior to lumber in strength and they are usually squeak-less. Beams supported by steel jacks were also present. **SEE PHOTOS.**

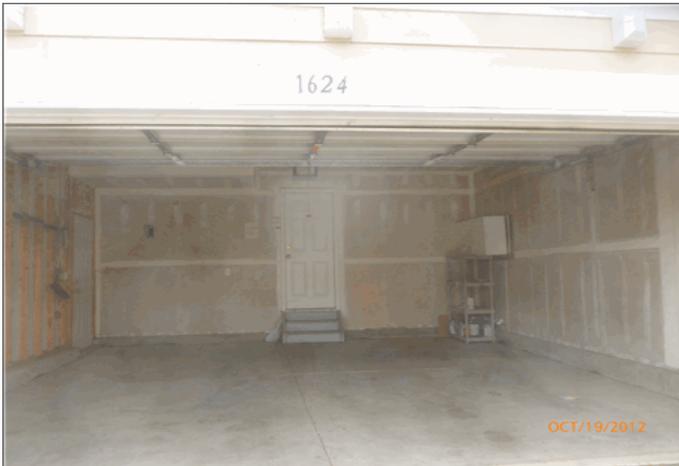
57) Drywalled Walls - Conditions

The drywalled walls appeared to be in serviceable condition.
SEE PHOTO.
