# **FOLLOWING IS A SAMPLE OF A RESIDENTIAL INSPECTION REPORT COPYRIGHTED BY FORESIGHT ENGINEERING & INSPECTIONS, LLC.**

REPORT # SMC 10A-XXXX

A SINGLE FAMILY RESIDENCE AT  
**XXXXXXXX, HOUSTON, TX 77077**

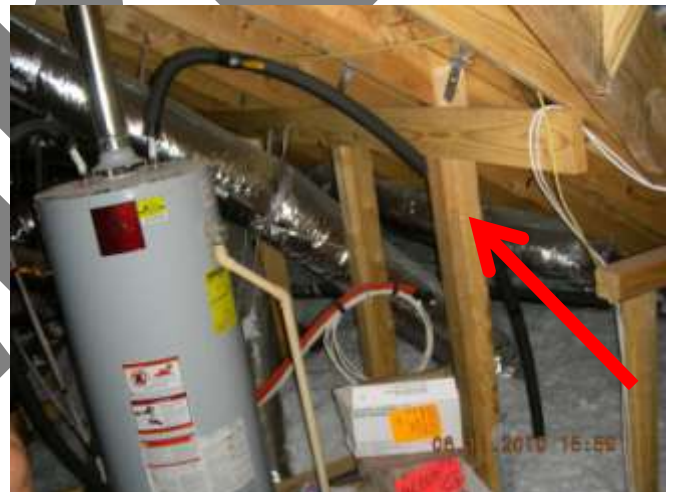
- 8. Improper bracing angle or bracing in the plane of purlin was observed behind the water heater. Angle should be between 45° and 75°. Installation does not comply with common industry standards and should be promptly attended to. (See photo middle right)
- 9. Fireplace chimney was observed to be touching roof and ceiling framing. There was no 2" clearance away from combustibles. (See photo below)

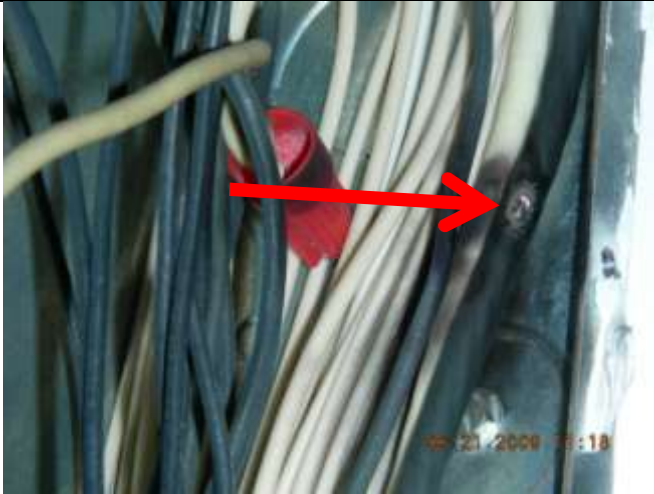
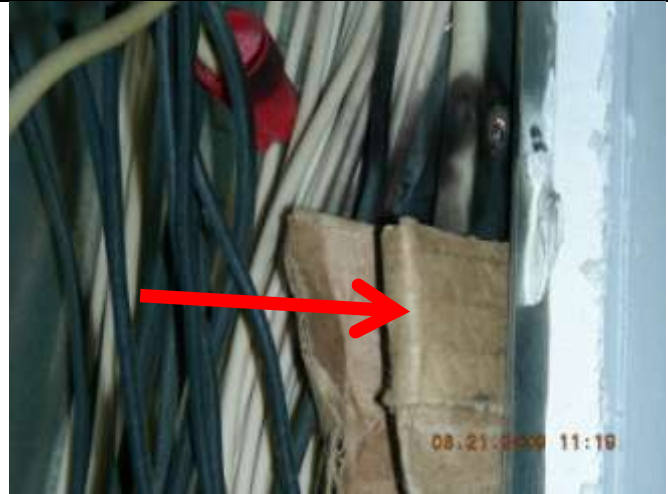
5. Neutral wires were double/triple lugged in neutral buss bar. Only one wire/screw is recommended. (See top right photo)
6. A hot wire was punctured while installing top right screw in the panel box causing shortage and fire because wire bundle was up against the panel and putting lot of pressure against the lip of the panel. This caused the puncturing and burning of the insulation. See bottom left and right photos. A cardboard was installed between wire and panel box to force the wire away from the panel lip. See bottom right photo. Top screw was not installed. This condition should be promptly corrected as it is unsafe.
